State of Illinois
ENVIRONMENTAL PROTECTION AGENCY
MEMORANDUM

SUBJECT: 1198010003 – Madison County
Estate of Chemetco
FOS File

On December 9, 2010, Michelle Cozadd and I conducted an inspection at Chemetco, Inc. Present during this inspection were Jorge Garcia, ES&H Manager for the Estate of Chemetco and Mike Murray of AIS.

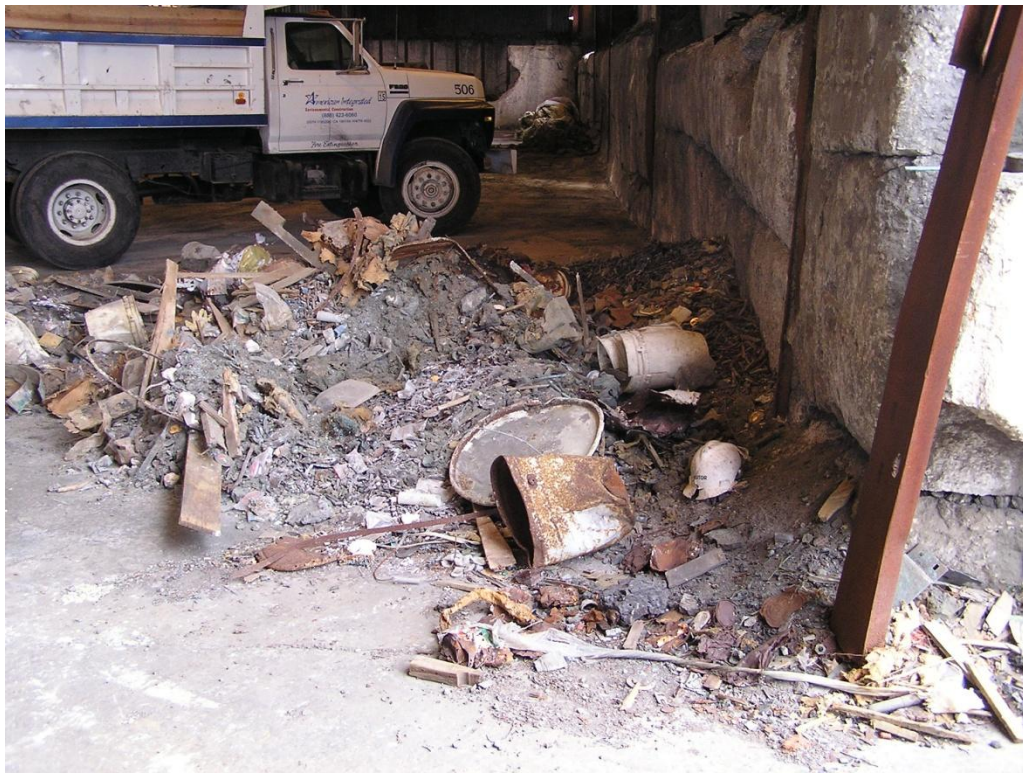
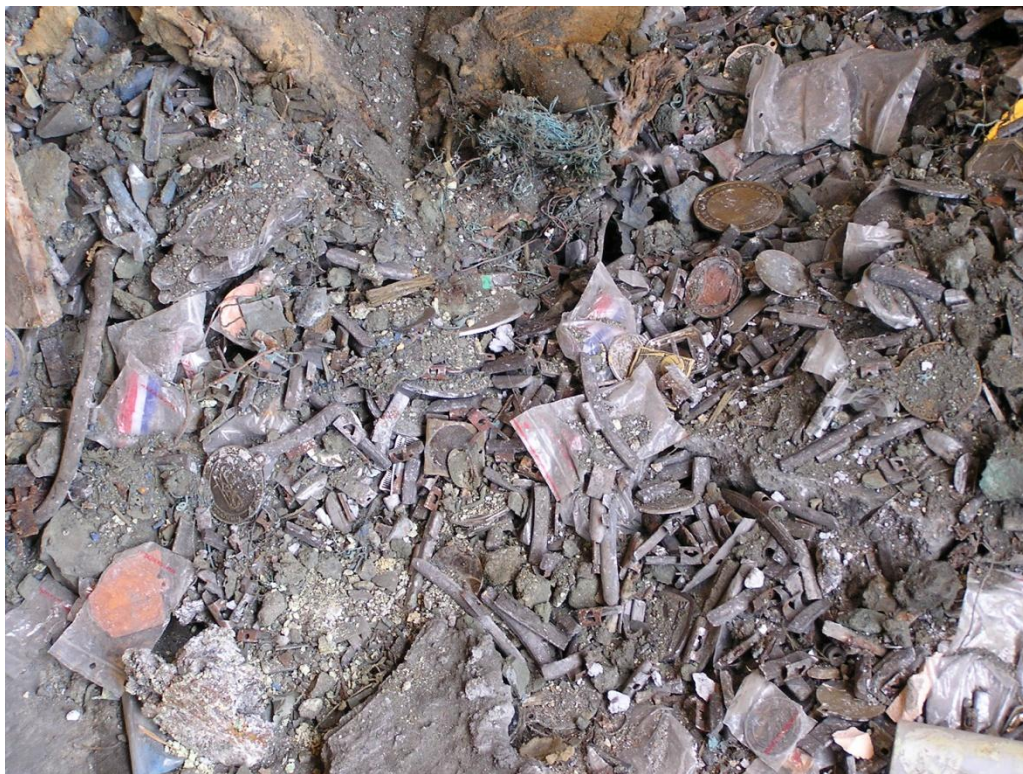
I observed the interior of the Foundry Building from the door way. I observed the spilled material from the 24 disintegrated containers. The pile contained lead wheel weights and medallions that are given as awards and prizes. Also in this pile, I observed dust, buckets, wood, pieces of pallets and other material (See photos 001 and 002).

Date: 12/09/2010
Time: 9:00 – 10:00
Direction: South
Photo by: Chris Cahnovsky
Exposure #: 001
Comments: Received material that was formerly in containers in the Foundry that were not moved to the Receiving Building

Date: 12/09/2010
Time: 9:00 – 10:00
Direction: South
Photo by: Chris Cahnovsky
Exposure #: 002
Comments: Received material that was formerly in containers in the Foundry that were not moved to the Receiving Building

An additional 24 drums in the Foundry Building also were in poor condition and disintegrated. The contents of these drums was also scattered on the foundry floor. These drums contained a mixture of medallions, automobile lead weights and other debris. This material was moved to just inside of the south side of the west wall. The Estate expects to sell this material in the near future.

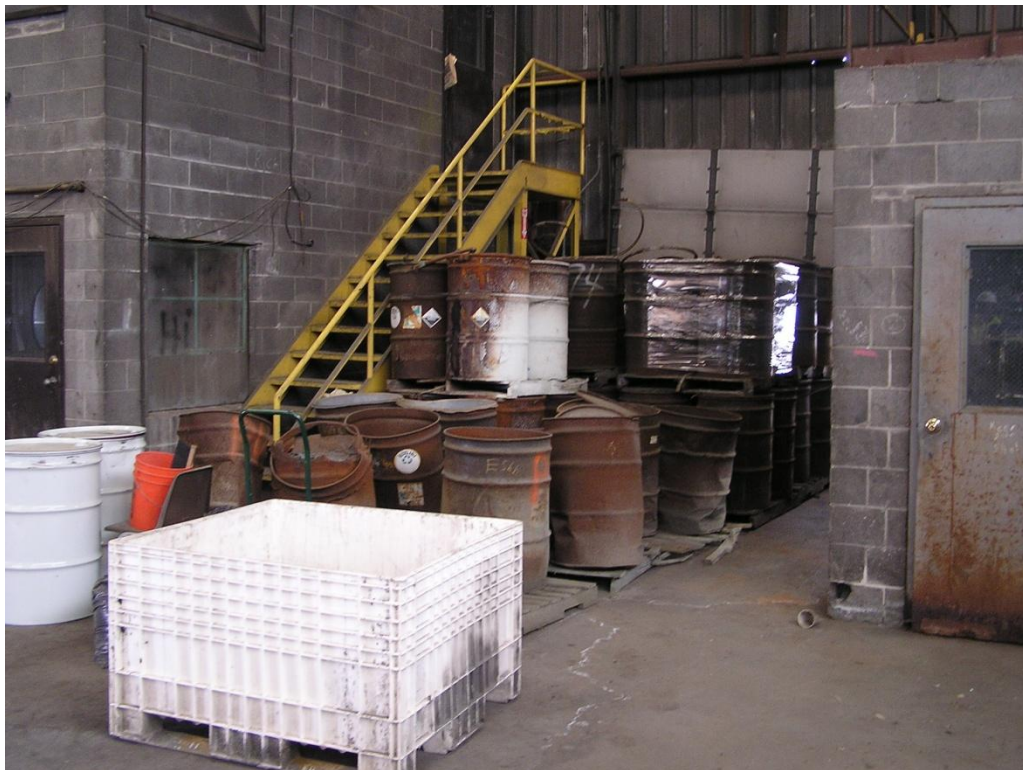
About 155 drums and totes from the Foundry Building have been moved to the Receiving Building. In this building I observed 55-gallon steel drums, fiber Gaylord boxes, 55-gallon fiber drums and plastic tote containers of smelter feedstock. About 17 of the 55-gallon steel drum and all of the fiber Gaylord boxes and 55-gallon fiber drums appeared to be in poor condition. (Photos 003-005).

Date: 12/09/2010
Time: 9:00 – 10:00
Direction: South
Photo by: Chris
Cahnovsky
Exposure #: 003
Comments: Drums
moved from
Foundry Building to
Receiving Building

According to the Revised Final Demolition Plan dated July 20, 2010, the former furnace feed materials that cannot be processed on-site during pending metals processing will be transferred to DOT-approved shipping container inside the Foundry Building during the performance of debris collection activities. These repackaged materials will be sealed and labeled and will remain temporarily stored inside the Foundry Building until they are shipped off site. If the material needed to be moved from the Foundry Building Industrial Assets and Disposition, LLC was to give IEPA advanced notification. The IEPA was told by the Estate that the Estate was planning on moving drums but no specific date was given.

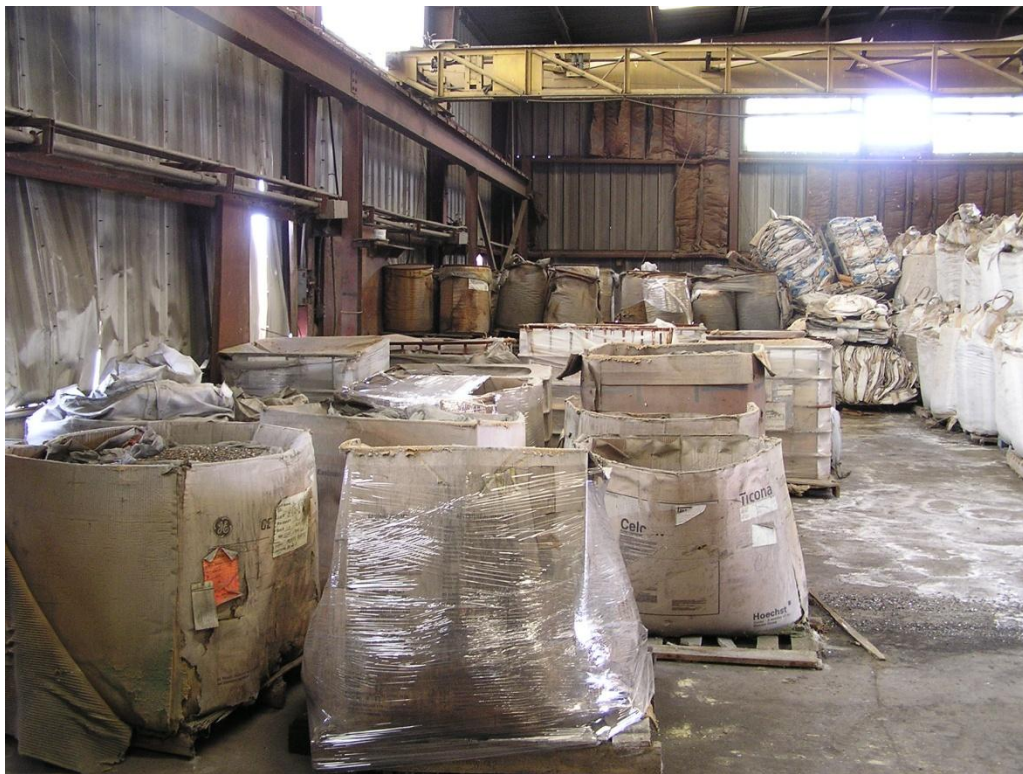
Date: 12/09/2010
Time: 9:00 – 10:00
Direction: North
Photo by: Chris
Cahnovsky
Exposure #: 004
Comments: Drums
moved from Foundry
Building to Receiving
Building

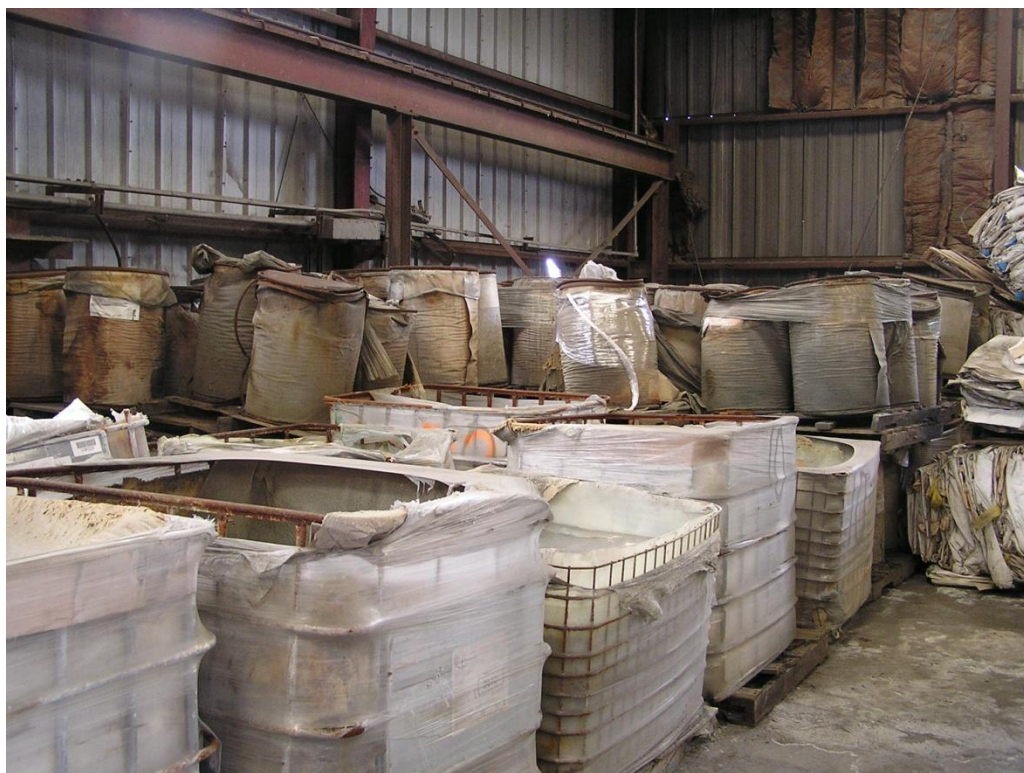
Date: 12/09/2010
Time: 9:00 – 10:00
Direction: North
Photo by: Chris
Cahnovsky
Exposure #: 005
Comments: Drums
moved from
Foundry Building to
Receiving Building

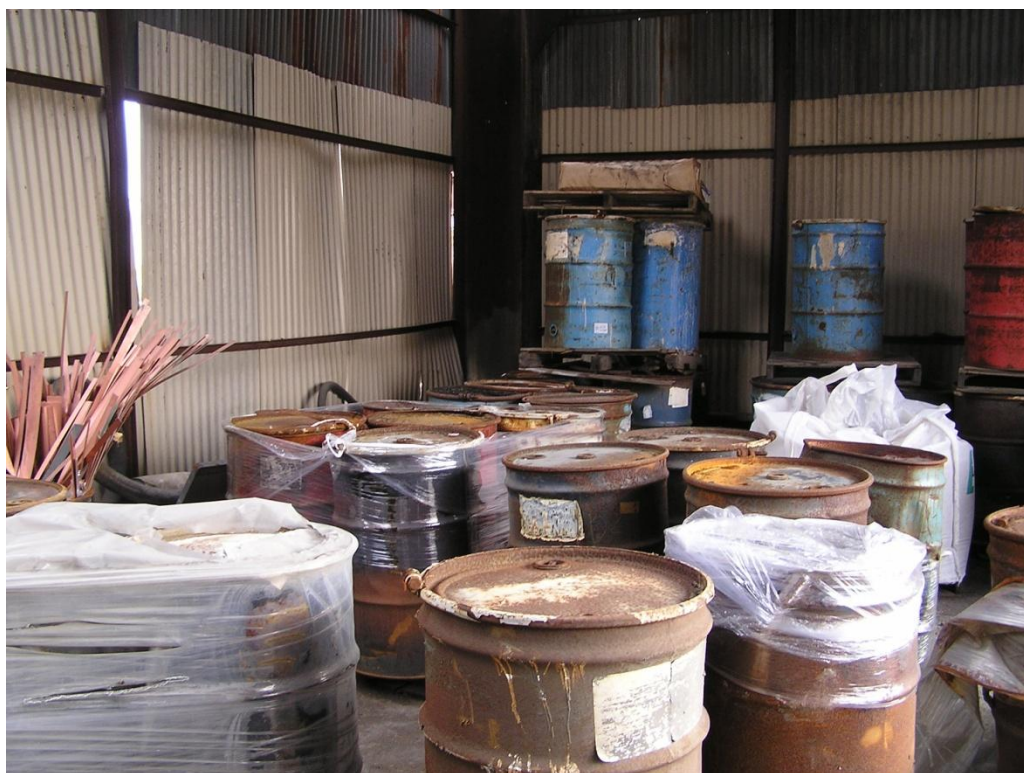
Date: 12/09/2010
Time: 9:00 – 10:00
Direction: East
Photo by: Chris
Cahnovsky
Exposure #: 006
Comments: Drums
moved from Foundry
Building to Receiving
Building

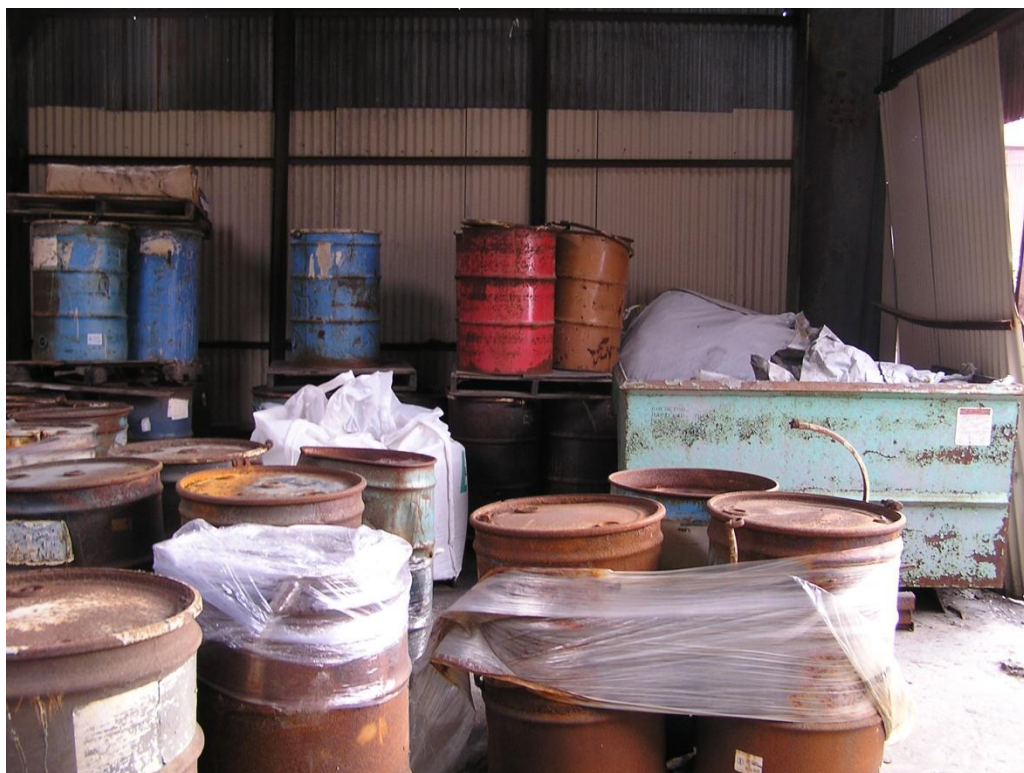
The smelter feedstock in containers that was left behind by Chemetco has been moved to the Receiving Building, the 90-Day Waste Storage Area and the Fines Building. Approximately 155 drums and totes were moved to the Receiving Building. This material included copper cement, tin mud, brass grindings copper paste, shredded circuit boards, heavy connectors, copper fines, and tin oxides. Approximately 17 drums were moved to the 90-Day Waste Storage Area. These drums contained tin fines. The contents of these 17 drums were similar to the tin fines that were already in the 90 day area. There are now 33 drums of tin fine drums in the 90 day area.

Date: 12/09/2010
Time: 9:00 – 10:00
Direction: East
Photo by: Chris
Cahnovsky
Exposure #: 007
Comments: Drums
moved from
Foundry Building to
90-day waste storage
building

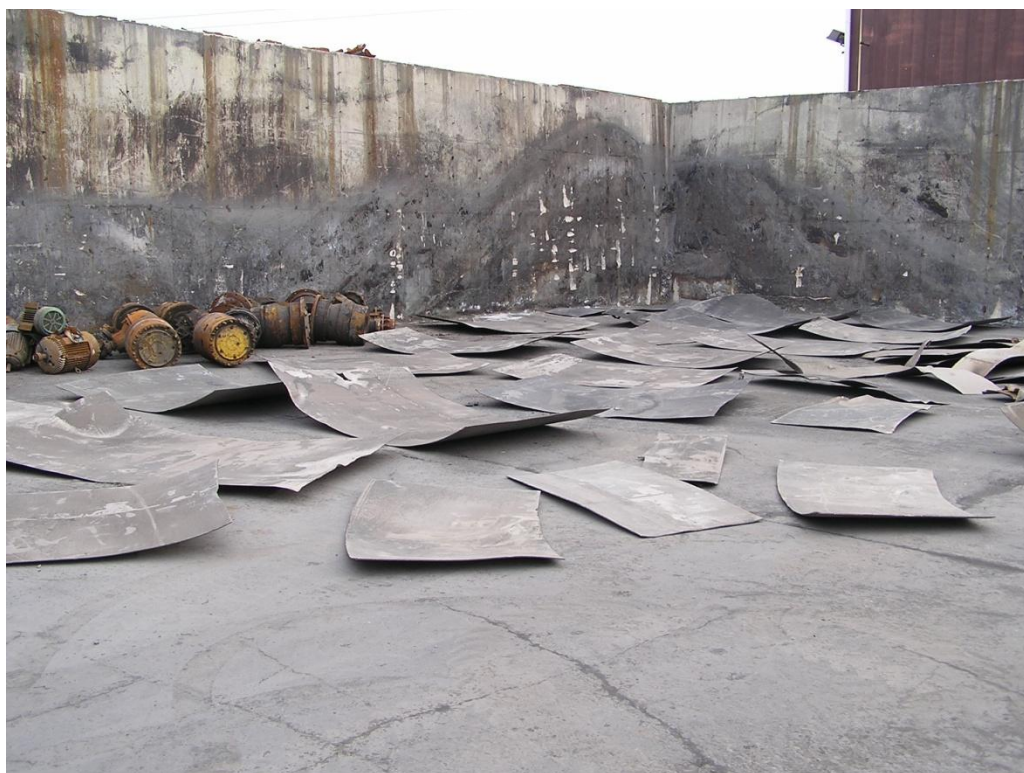
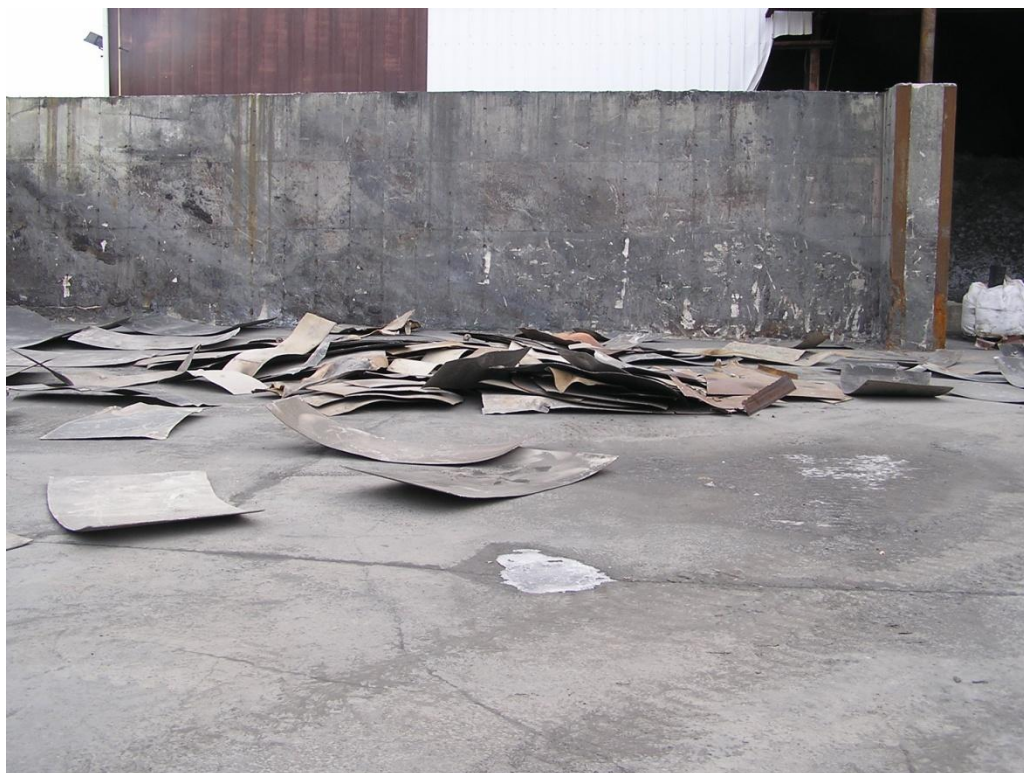
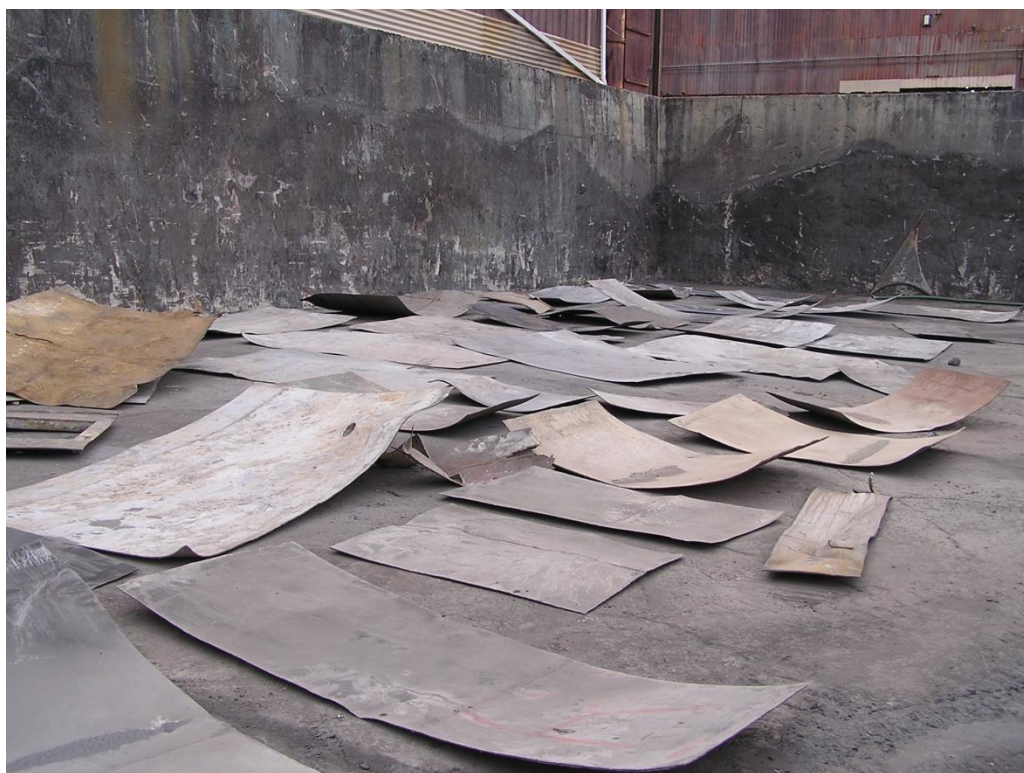
The sand blasting test trials on the stainless steel did not work. The spent sand from the test trail is in two one-cubic yard supersacks. Mr. Garcia has not yet sampled the spent sand. I observed many pieces of prepared scrap stainless steel on the floor of the Dome Building (Photos 008-012). The cold weather has prevented AIS from power washing the steel so far today. AIS has a heat coil on the waterline to the power washer and a heater next to the facility water supply tank. AIS is not sure how they are going to continue to decontaminate the steel in the cold weather.

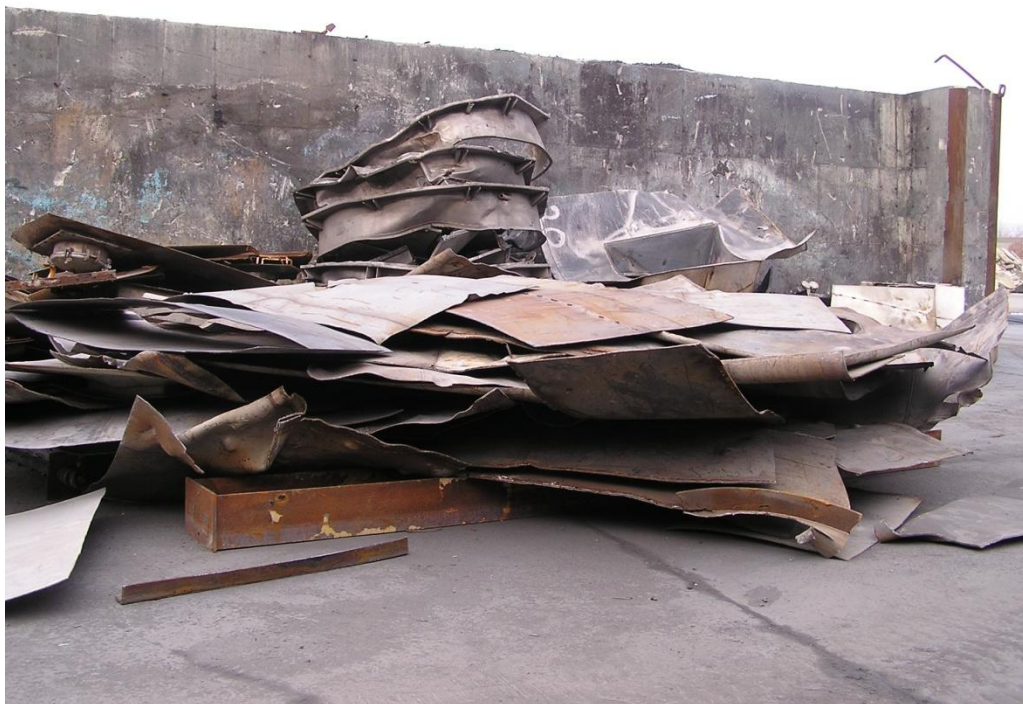
Date: 12/09/2010
Time: 9:00 – 10:00
Direction: West
Photo by: Chris
Cahnovsky
Exposure #: 011
Comments: cleaned
stainless steel

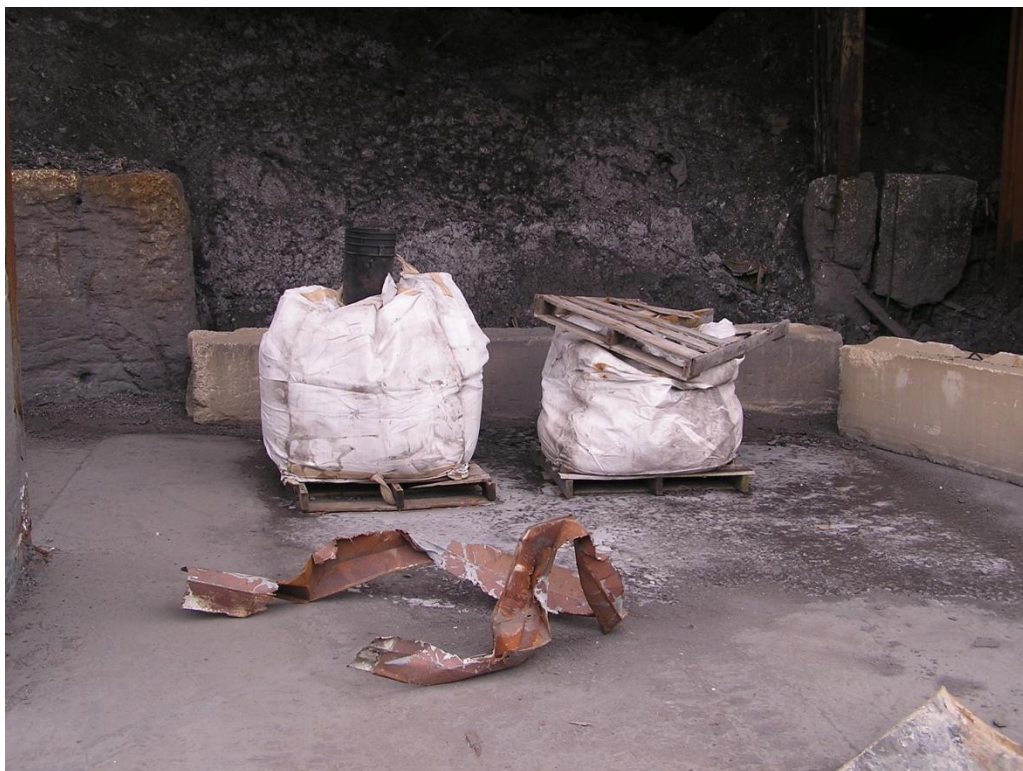
Date: 12/09/2010
Time: 9:00 – 10:00
Direction: East
Photo by: Chris
Cahnovsky
Exposure #: 012
Comments: Spent Sand
from blast trial

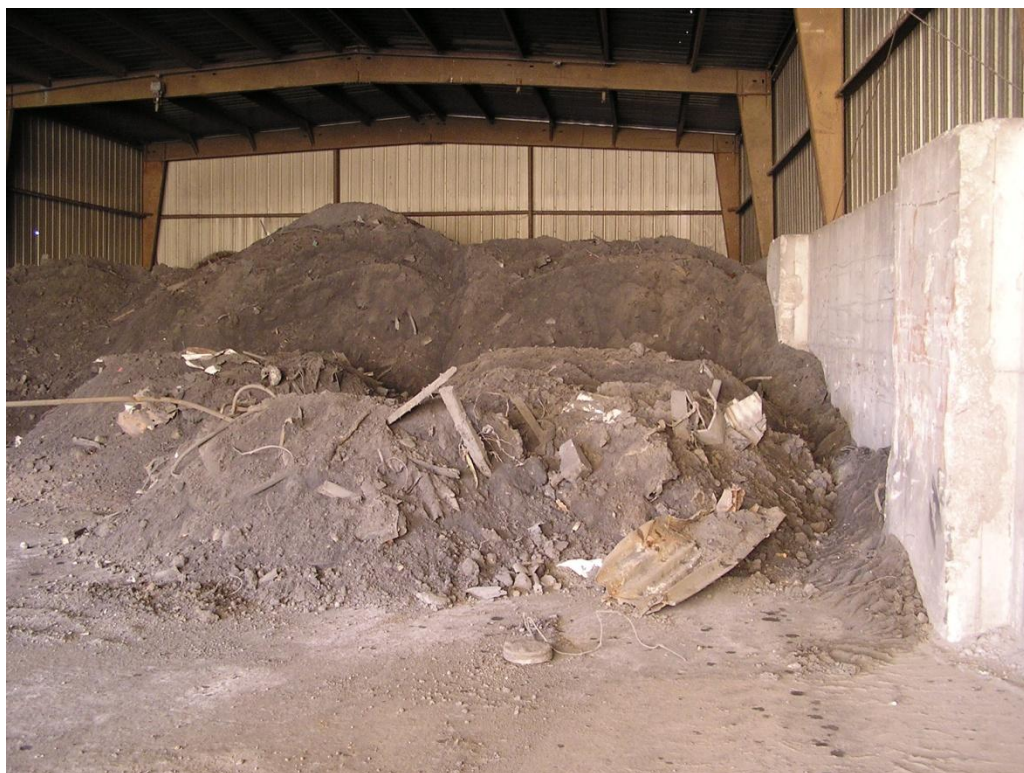
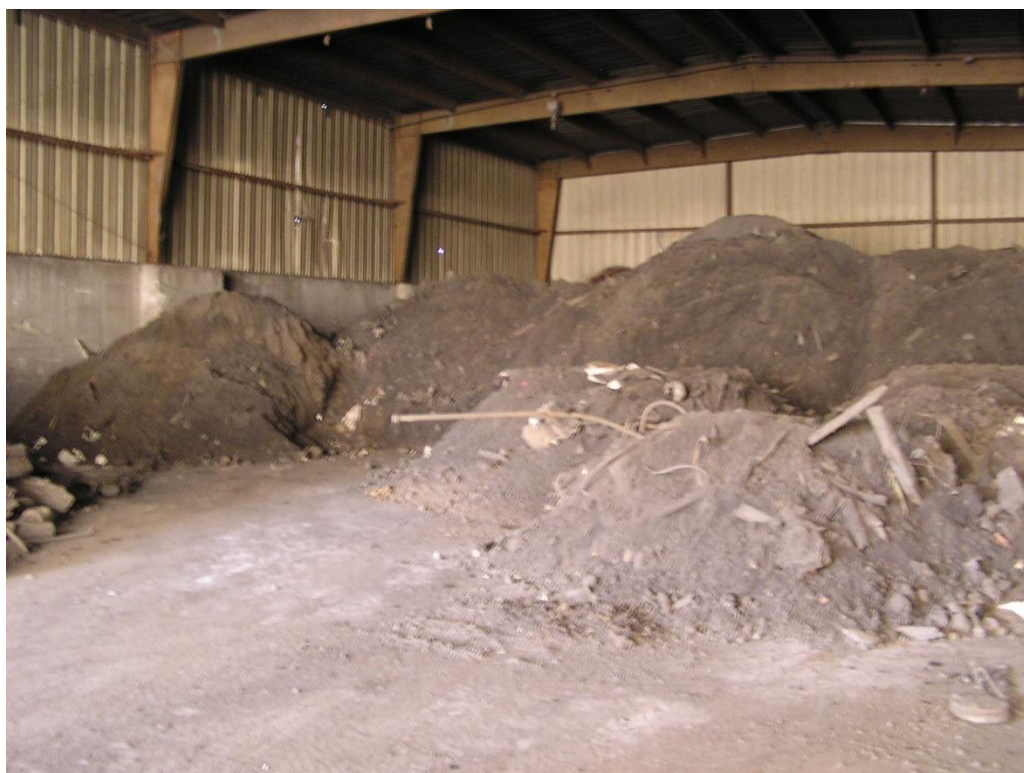
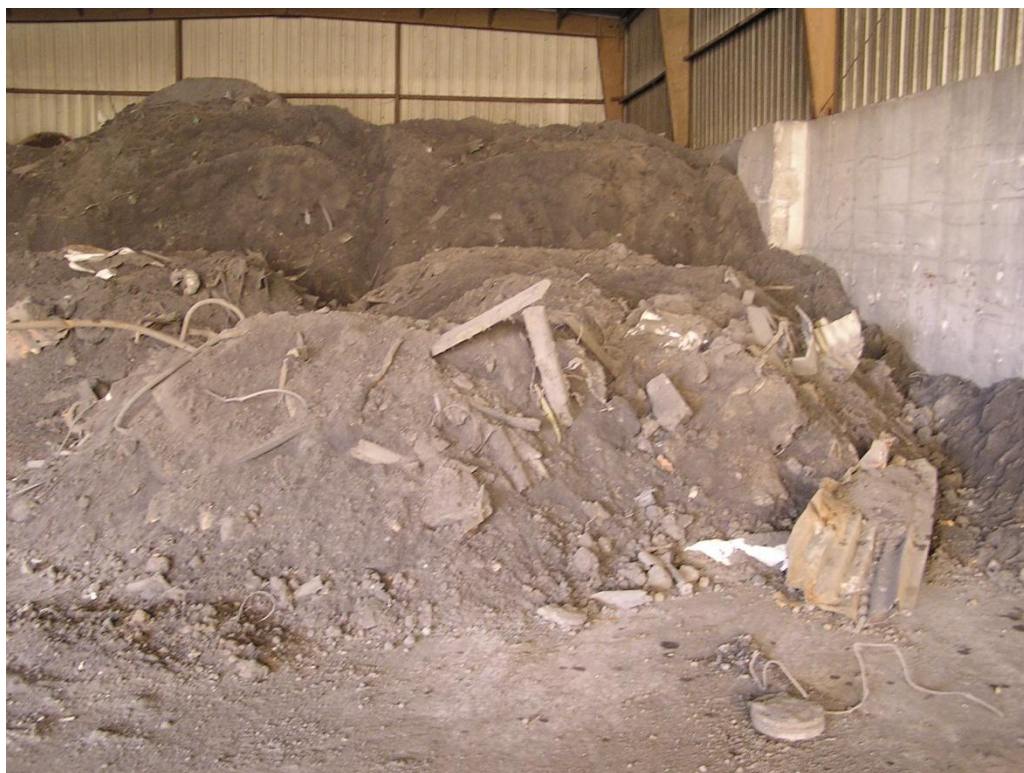
About 32 drums of tin mud, nickel copper cake and lead glass have been moved from the Foundry Building to the Fines Building and mixed with the MBM. In a December 20, 2010 email from Jorge Garcia, this material is being repackaged and taken to the Receiving Building. The hazardous waste concrete debris from the Tank House has not been removed from the Fines Building.

Date: 12/09/2010
Time: 9:00 – 10:00
Direction: Northwest
Photo by: Chris
Cahnovsky
Exposure #: 013
Comments: Fines
Building

Date: 12/09/2010
Time: 9:00 – 10:00
Direction: Northwest
Photo by: Chris
Cahnovsky
Exposure #: 014
Comments: Fines
Building

Date: 12/09/2010
Time: 9:00 – 10:00
Direction: Northwest
Photo by: Chris
Cahnovsky
Exposure #: 015
Comments: Fines
Building

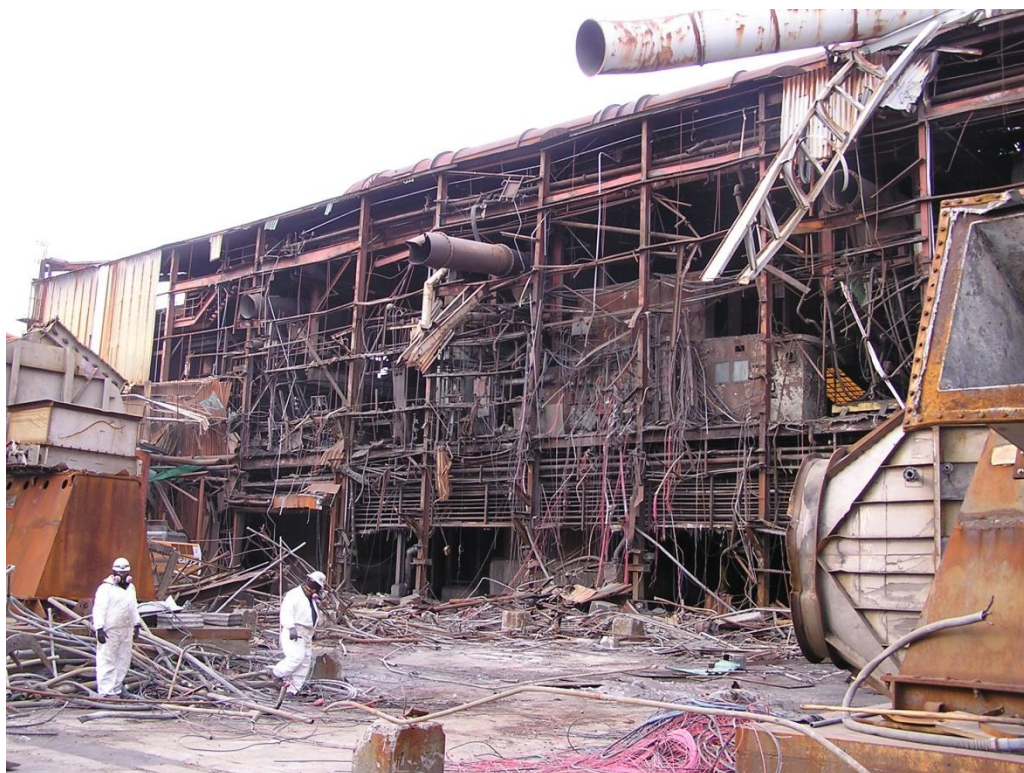
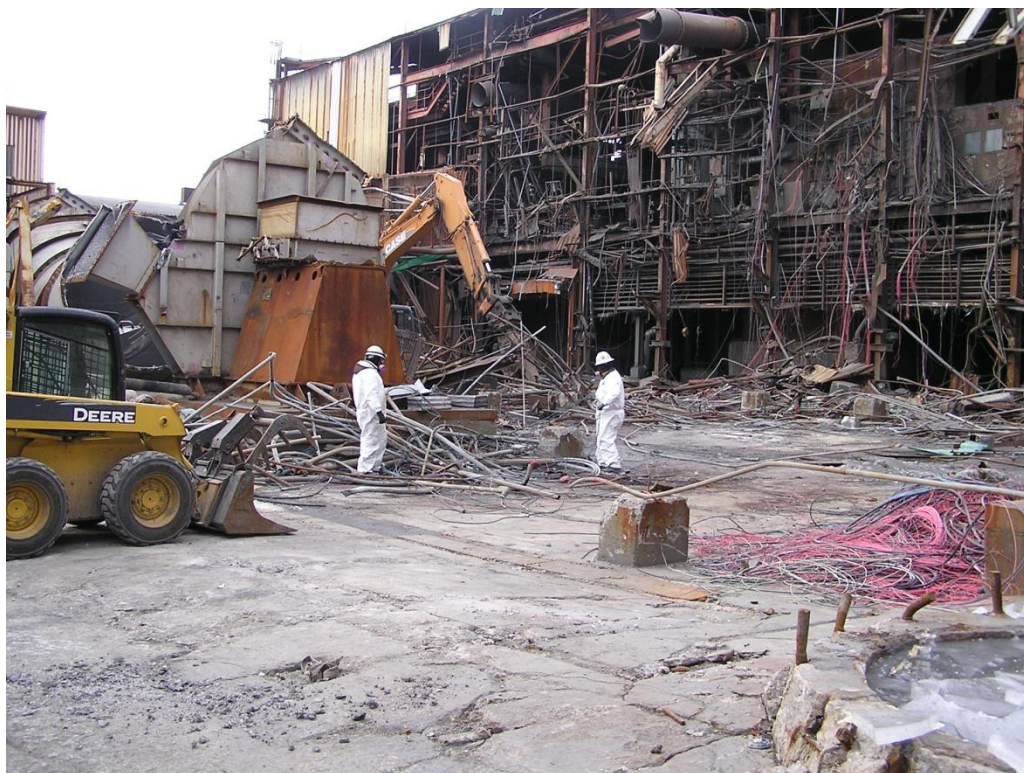
The rear wall of the Foundry Building has been removed. AIS crews are cutting steel and removing copper wire. The wire and metal conduit are being separated into piles (Photo 016-017). Steel is being loaded into boxes for delivery to Grossmen Metals. AIS has cut inspection holes in the hoppers of the baghouse on the south side of the foundry. It appears that the baghouse compartments are empty. Per Mr. Murray, this will make demolition of the baghouse easier since there is only a small amount of dust in the system.

Date: 12/09/2010
Time: 9:00 – 10:00
Direction: Southwest
Photo by: Chris
Cahnovsky
Exposure #: 016
Comments: Rear of
Foundry Building

Date: 12/09/2010
Time: 9:00 – 10:00
Direction: Southwest
Photo by: Chris
Cahnovsky
Exposure #: 017
Comments: rear of
Foundry Building

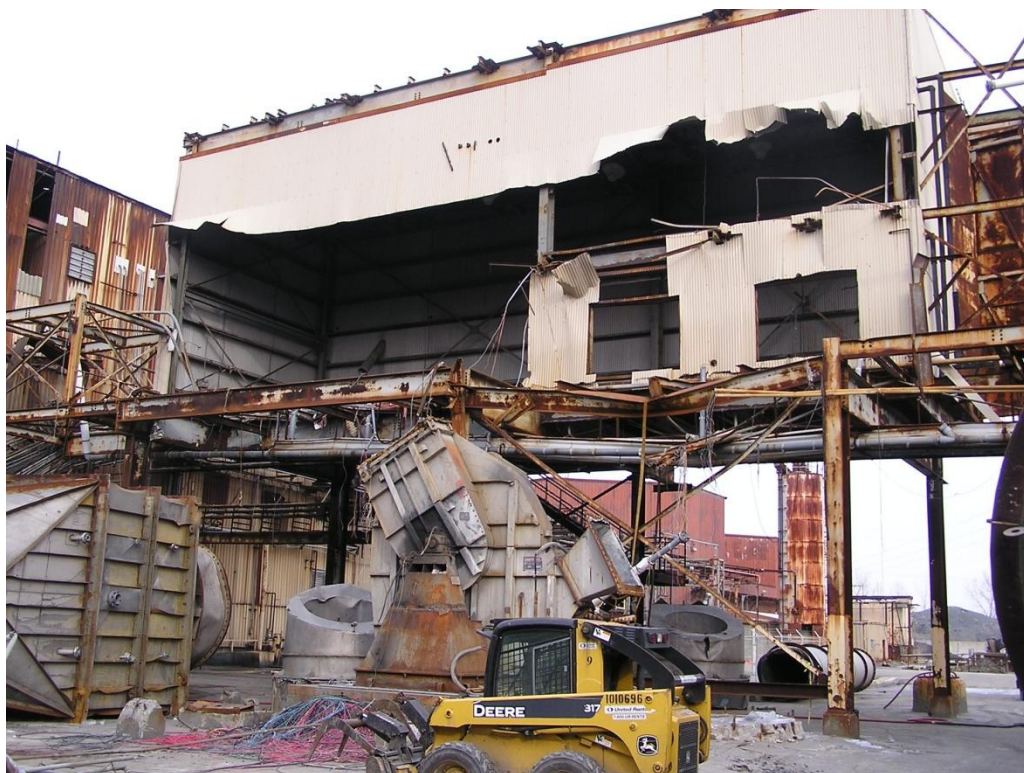
Date: 12/09/2010
Time: 9:00 – 10:00
Direction: Northwest
Photo by: Chris
Cahnovsky
Exposure #: 020
Comments: This
structure will stay after
demo

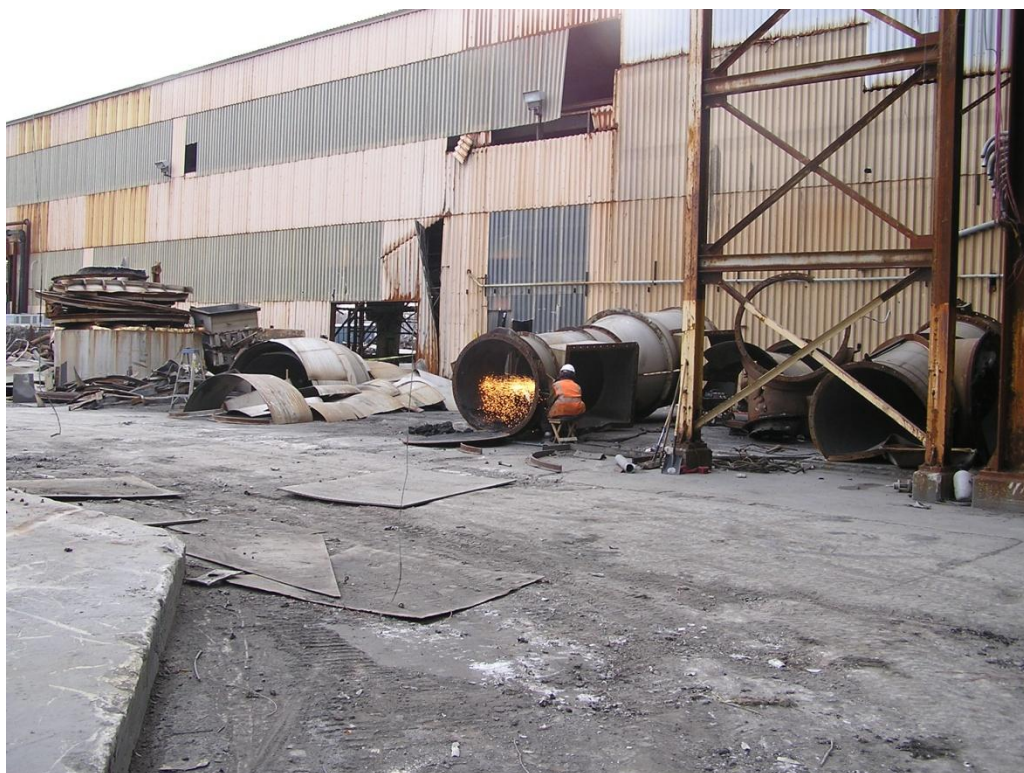
The AAF demolition is essentially complete. AIS is still cutting up the stainless steel duct work and moving it to the Dome Building for decontamination.

Date: 12/09/2010
Time: 9:00 – 10:00
Direction: Southeast
Photo by: Chris
Cahnovsky
Exposure #: 022
Comments: cutting
stainless steel

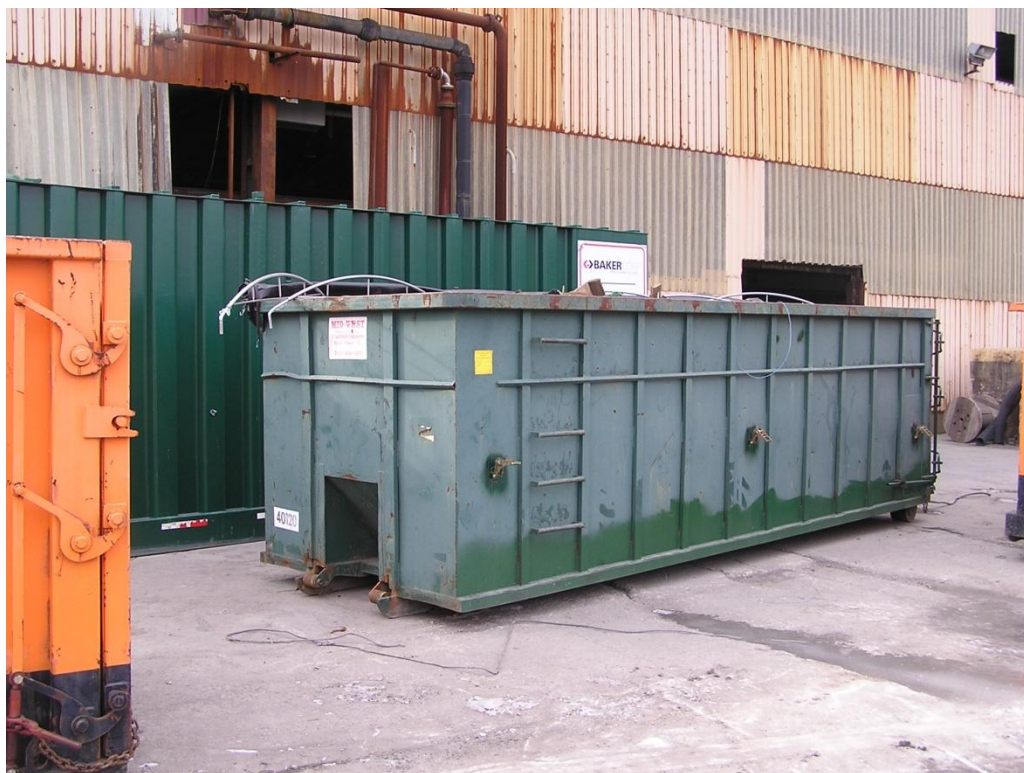
Date: 12/09/2010
Time: 9:00 – 10:00
Direction: Southwest
Photo by: Chris
Cahnovsky
Exposure #: 023
Comments: current
RCRA container

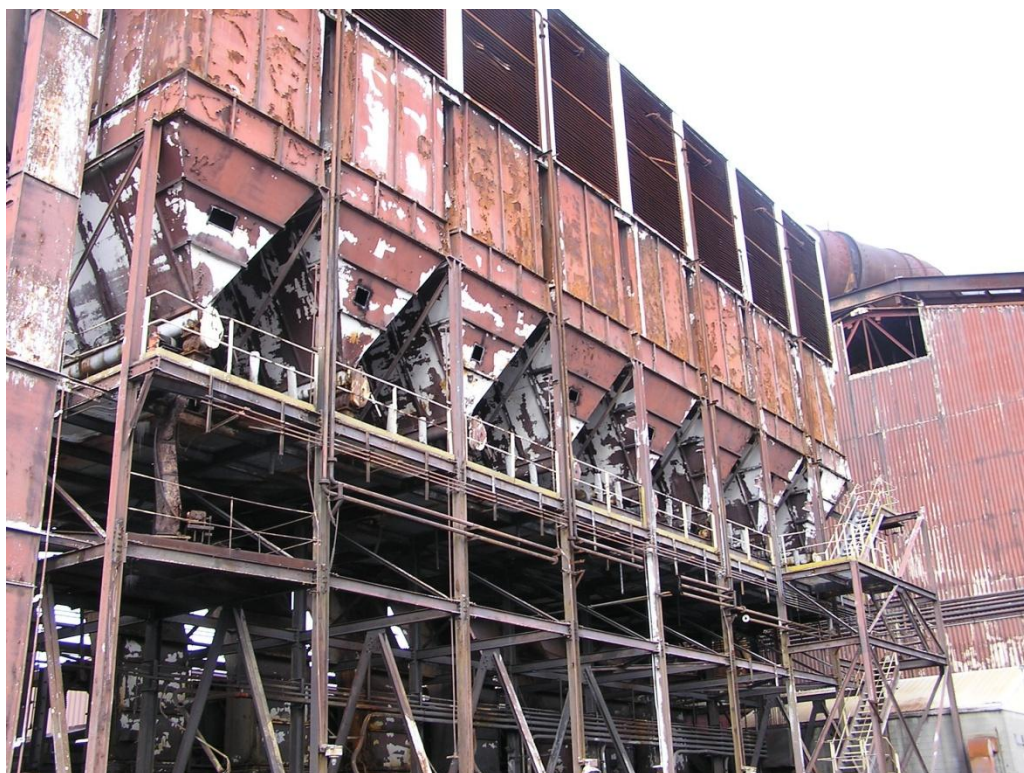
Date: 12/09/2010
Time: 9:00 – 10:00
Direction: Northwest
Photo by: Chris
Cahnovsky
Exposure #: 024
Comments: Holes cut
in baghouses
